LANDSLIDES AND RELATED FEATURES

OF THE OLD BETHEL, ALA. QUADRANGLE

by
John S. Pomeroy
1982

U.S. Geological Survey
OPEN FILE MAP 82-181 (E-4)

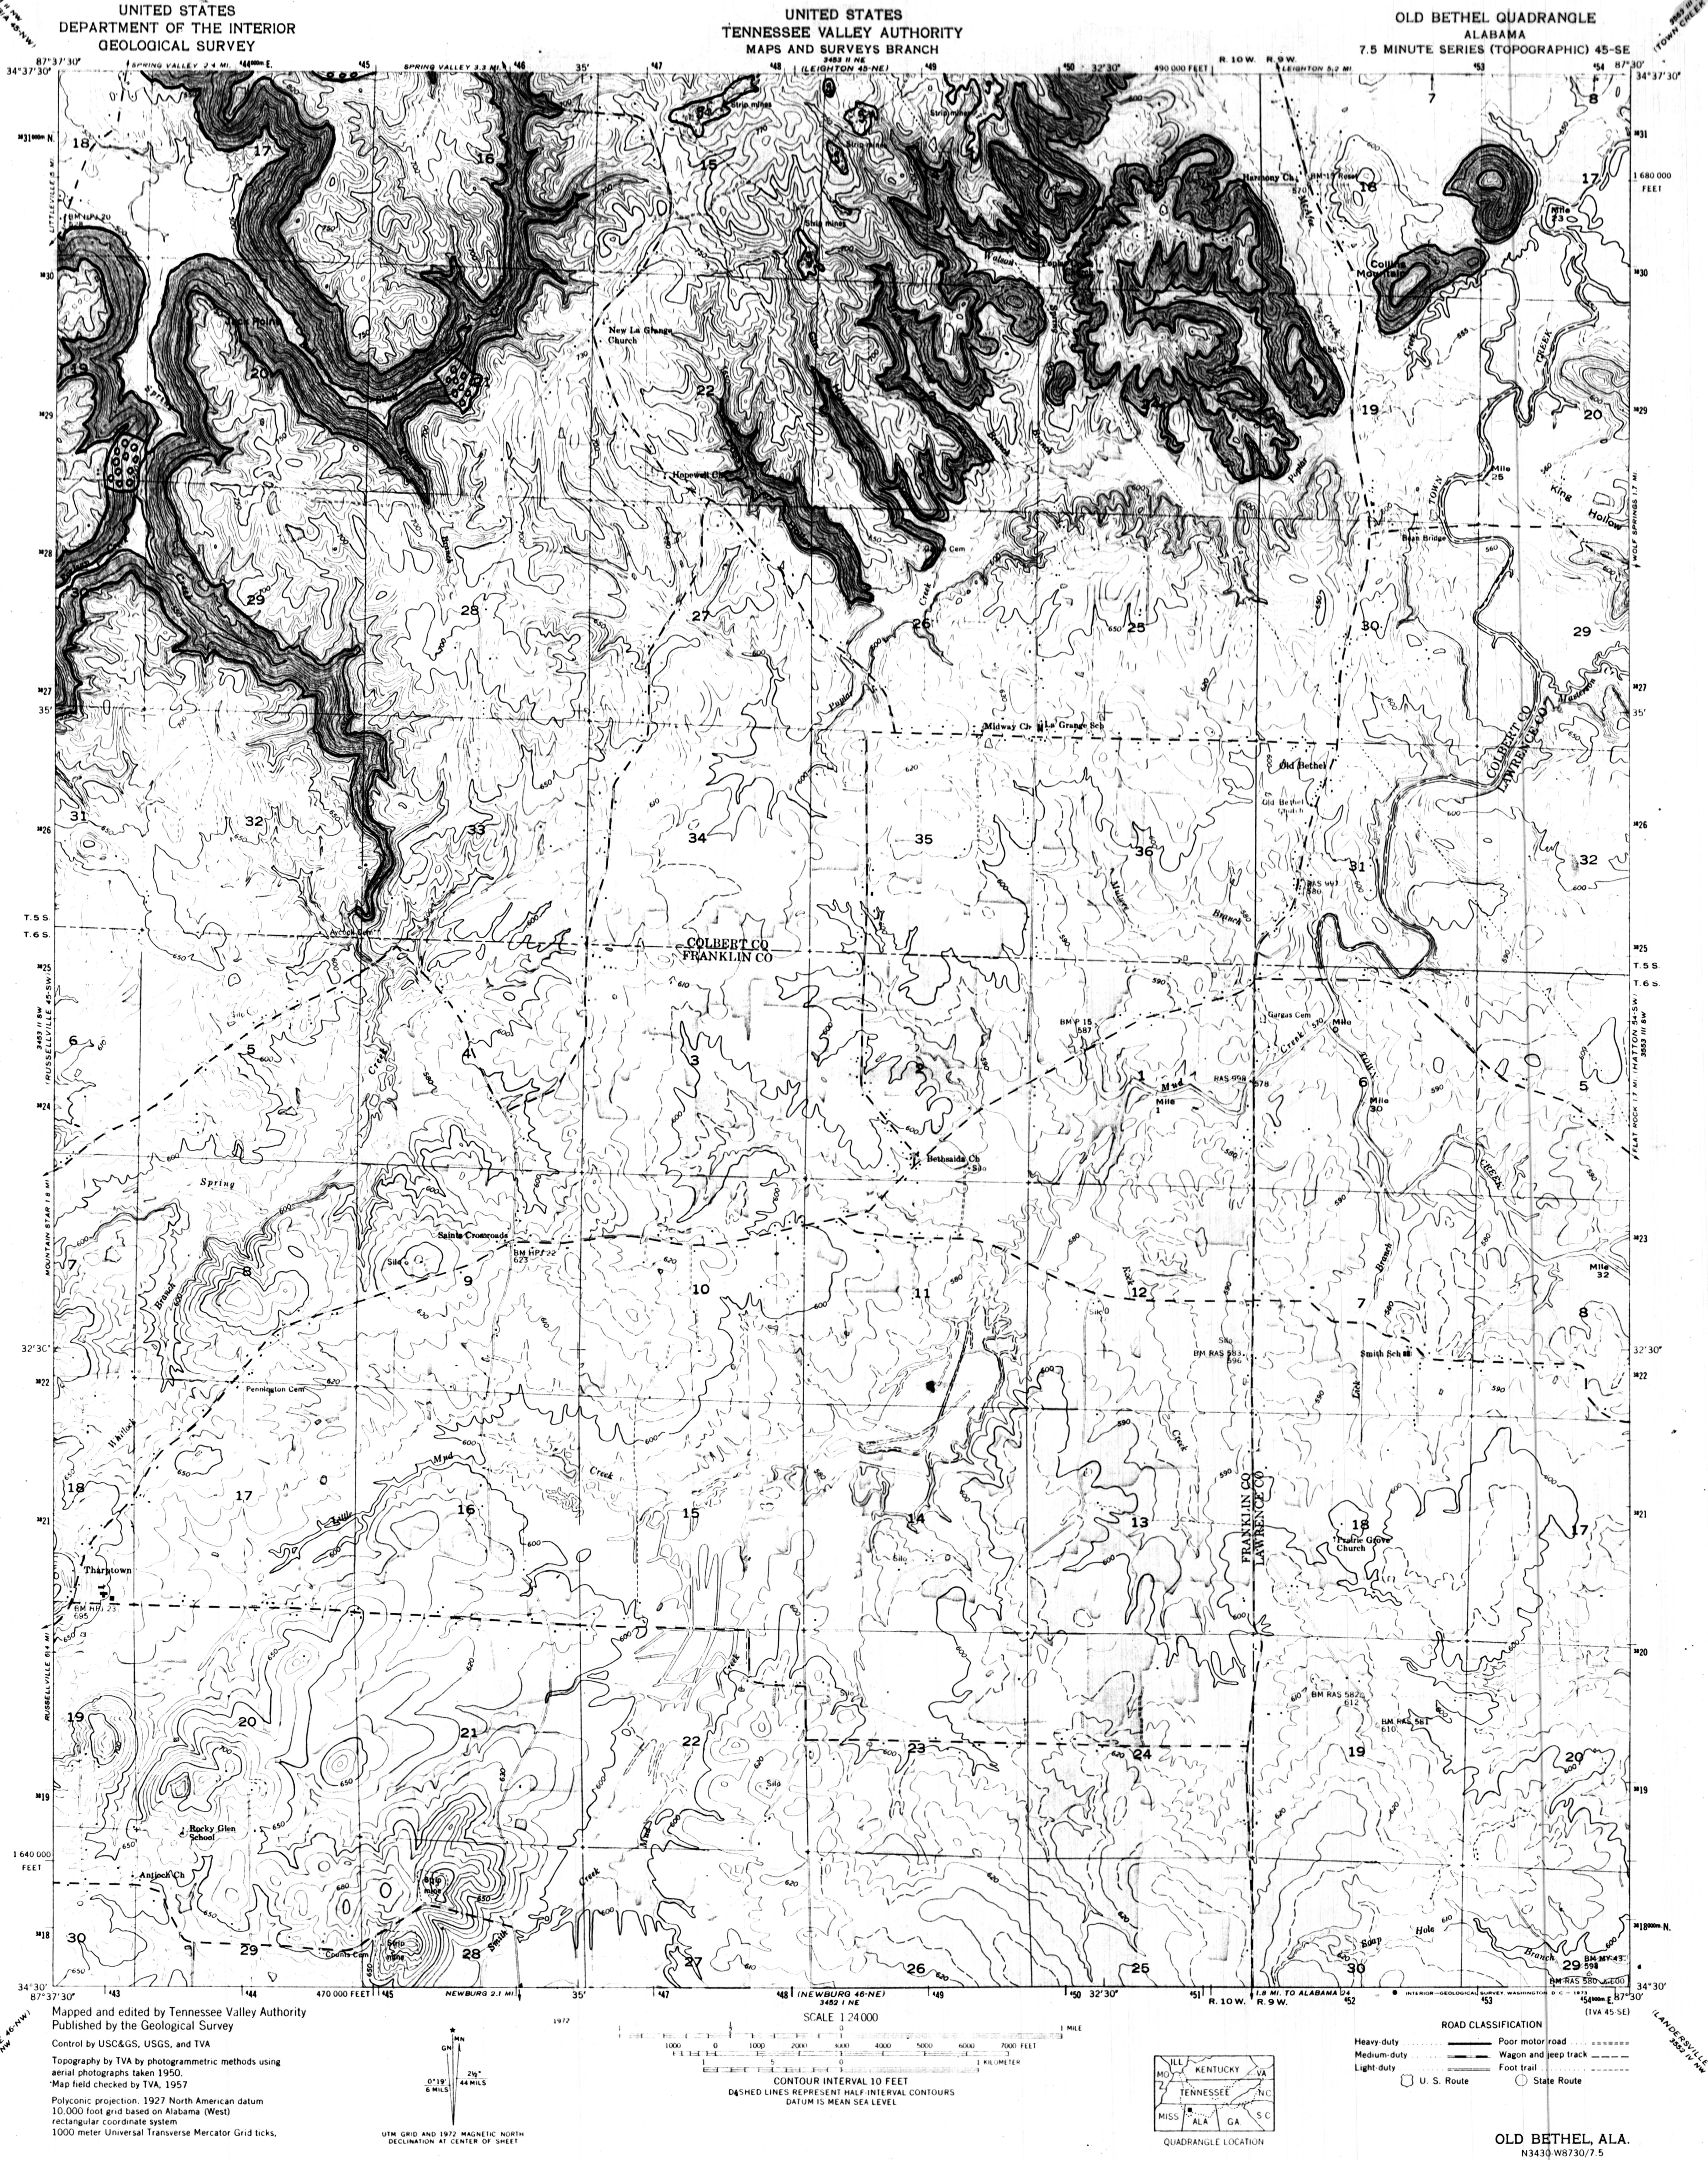
Landslides and related features interpreted
from aerial photographs:
1:20,000 (black and white) 1971, 1972
1:40,000 (black and white) 1978

Photointerpretation and field check 1980-1981
This map is preliminary and has not been reviewed
for conformity w/ U.S. Geological Survey editorial
standards

ACTIVE OR RECENTLY ACTIVE LANDSLIDE
Complex landslide composed of earthflow, debris
slide, earth and rock slump. Identified from
historical records, and from scars, debris and
other field evidence. Ground extremely unstable;
sliding accelerated by excavation, loading and
changes in drainage conditions. May include
areas with several active slides too small to
be shown separately. Questioned where doubtful.
May be shown with symbol (a) where difficult to discern.

OLD LANDSLIDE
Area of extensive hummocky ground caused by
earthflow and earth and rock slump. Lacks
clear evidence of active sliding. Relatively
stable in natural, undisturbed state,
generally not affected by small structures properly
sited in areas away from the edge of the toe;
can be reactivated by extensive, rapid exca-
vation, loading, and changes in ground water and
surface water conditions. Area of old landslide
probably includes recent ones not identified
from field evidence or otherwise documented.
Upslope boundary of landslide generally defined
by modified scarp, but downslope (toe) may be
gradational and not well defined. Questioned
where doubtful.

**AREAS SUSCEPTIBLE TO DEBRIS FLOWS AND DEBRIS
AVAILANCES**
Primarily shallow, narrow ravines and chutes with
accumulation of stony colluvium generally 10 ft.
(3 m) or less in thickness; susceptible to rapid
movement during intense rainfall. Most ravines
and chutes designated show evidence of former
debris flows and avalanches. Symbol (a) design-
ates historical debris flow or debris avalanche.

AREAS SUSCEPTIBLE TO ROCKFALL
Steep, locally vertical, natural and man-made
slopes and cliffs, 15 ft. (4.5 m) or more high;
formed dominantly of sandstone, limestone, sandy
shale, mudstone and claystone. Interbedded mud-
stone, claystone and shale weather rapidly leaving
sandstone and limestone rock faces unsupported.

SOIL AND ROCK SUSCEPTIBLE TO LANDSLIDING
Soil and rock similar to that involved in land-
slides elsewhere in map area; primarily areas
underlain by claystone, mudstone and shale
associated with other rock types. Rock weathers
rapidly on exposure forming clayey soil highly
susceptible to sliding. Includes coves (U-shaped,
shallow valleys) containing thick layers of clayey
soil that are very susceptible to sliding where
excavation breaks continuity of slope and where
overloaded by artificial fill.

AREAS LEAST PRONE TO LANDSLIDES
Map areas in which no patterns or symbols are shown;
primarily valley floors, ridge tops and broad
benches; modification by excavation and fill may
lead to local landslides. Includes slopes where
landslides are sparse.
